FIELD REVIEW REPORT/DEFICIENCY REPORT

DATE OF VISIT:	December 5, 2018, January 29, 2019	REPORT NO.	02
WEATHER:	Sunny 7, Sunny 8		
OWNER:	Malahat Nation	PROJECT:	Multipurpose Building
TEL/FAX:		PROJECT #:	
CONTRACTOR:	Built Contracting Ltd.	REPORT BY:	Scott Kemp
TEL/FAX:	(604) 740-7861	DATE ISSUED:	February 3, 2019
PURPOSE:	Field Review / Deficiency Report

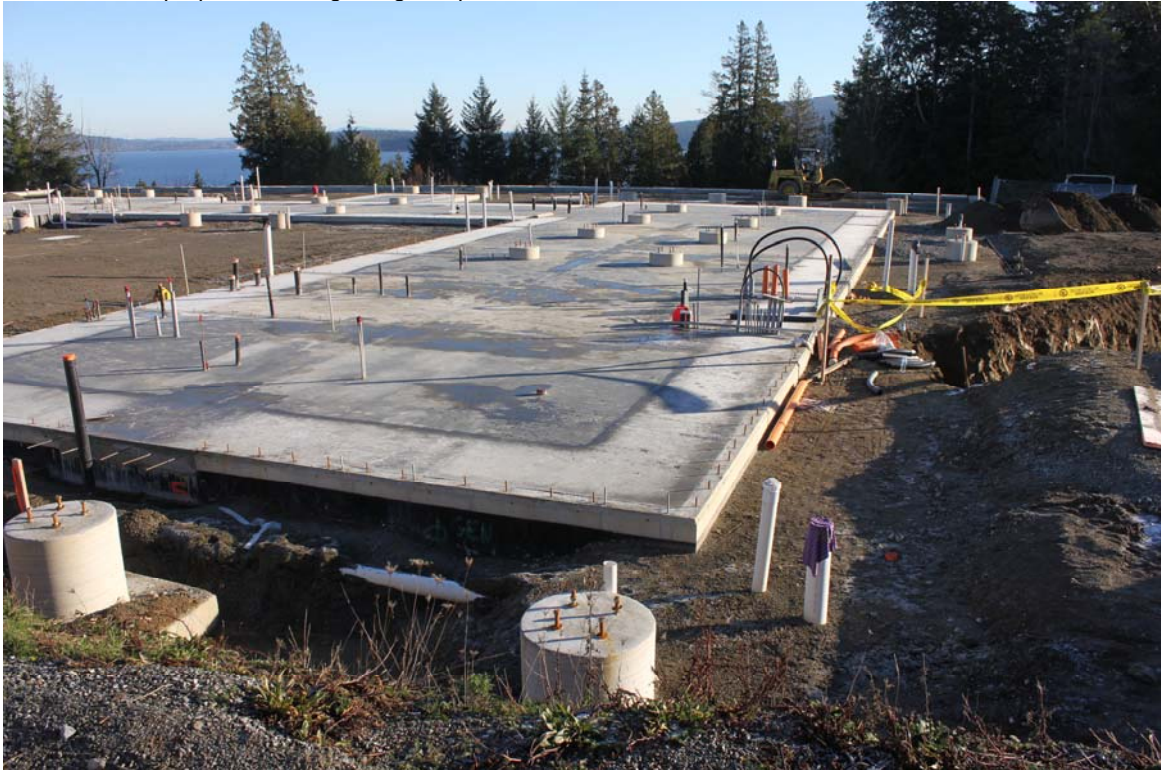
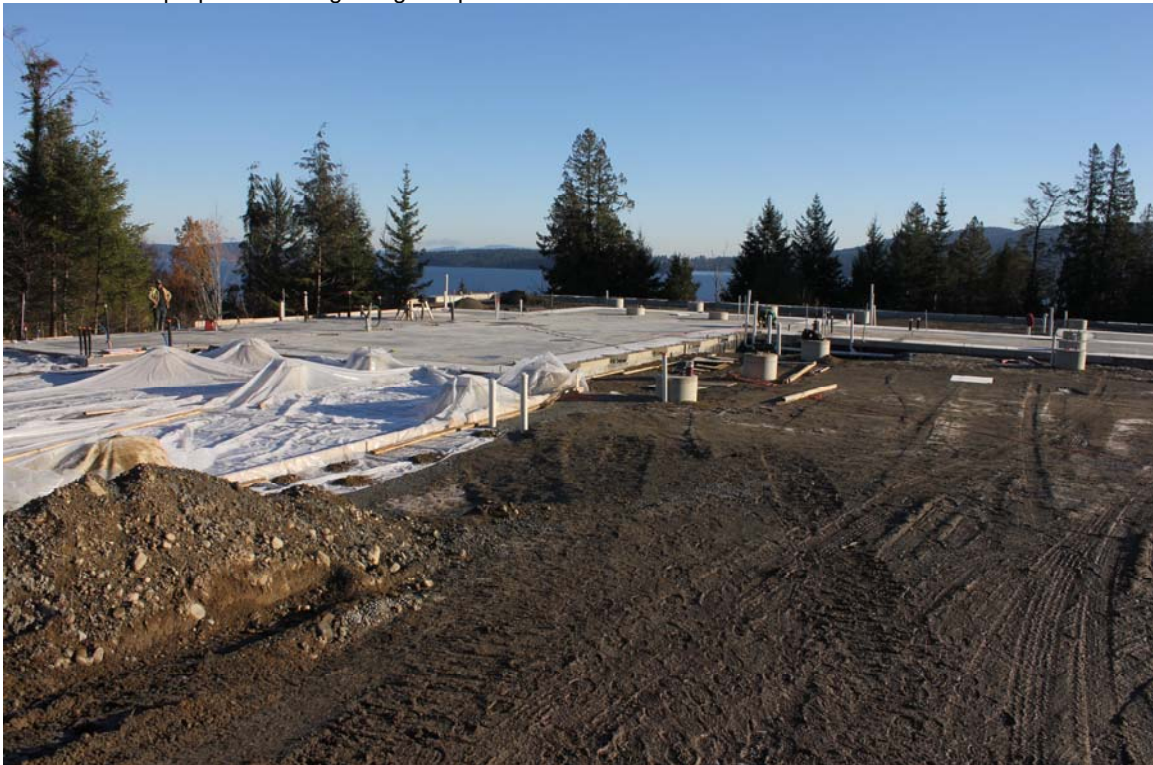
ITEM	PHOTO	COMPONENT	OBSERVATION	COMMENTS
December 59, 2018				
A1.1	01, 02	Progress photo	Foundation and slab in progress. Underground services installed	
A1.2	03	Civil work, north end of building	Additional fill required to provide adequate firefighting access around site	Civil engineer to issue additional information regarding fill and grading at north end of site

Photo 01: Multipurpose Building: Progress photo: Foundation and slab

Photo 02: Multipurpose Building: Progress photo: Foundation and slab

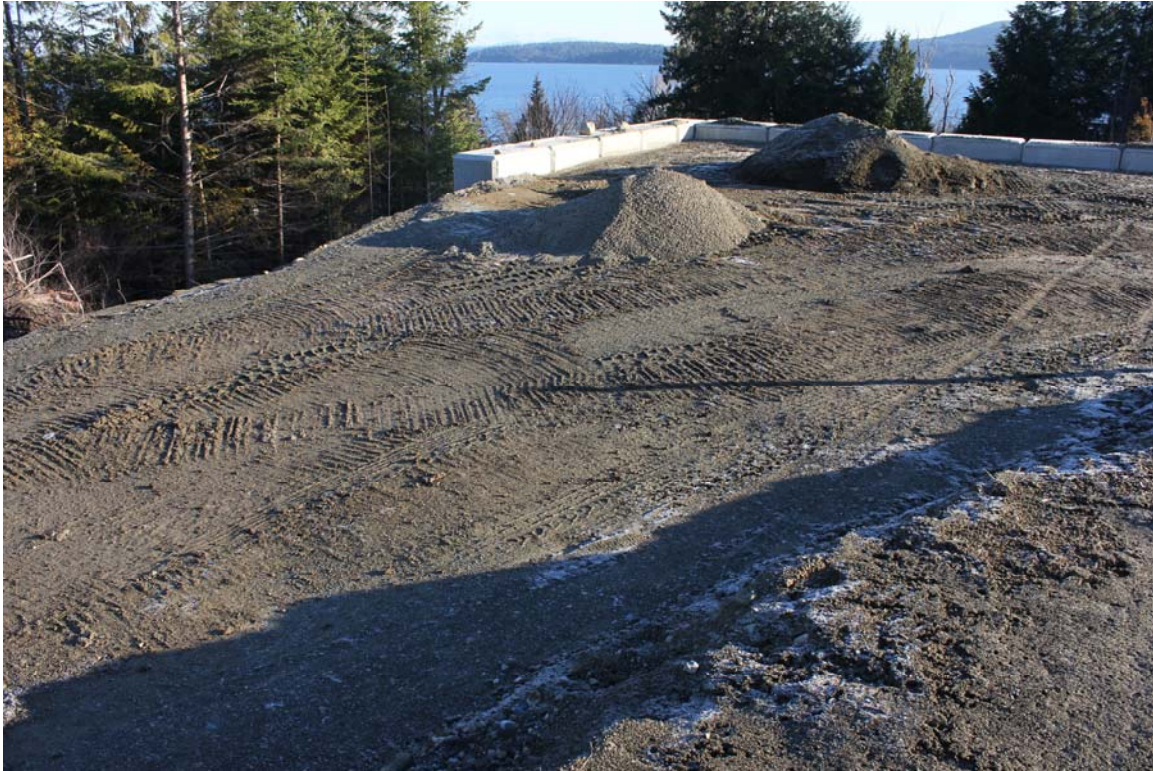
Photo 03: Civil work: north end of site

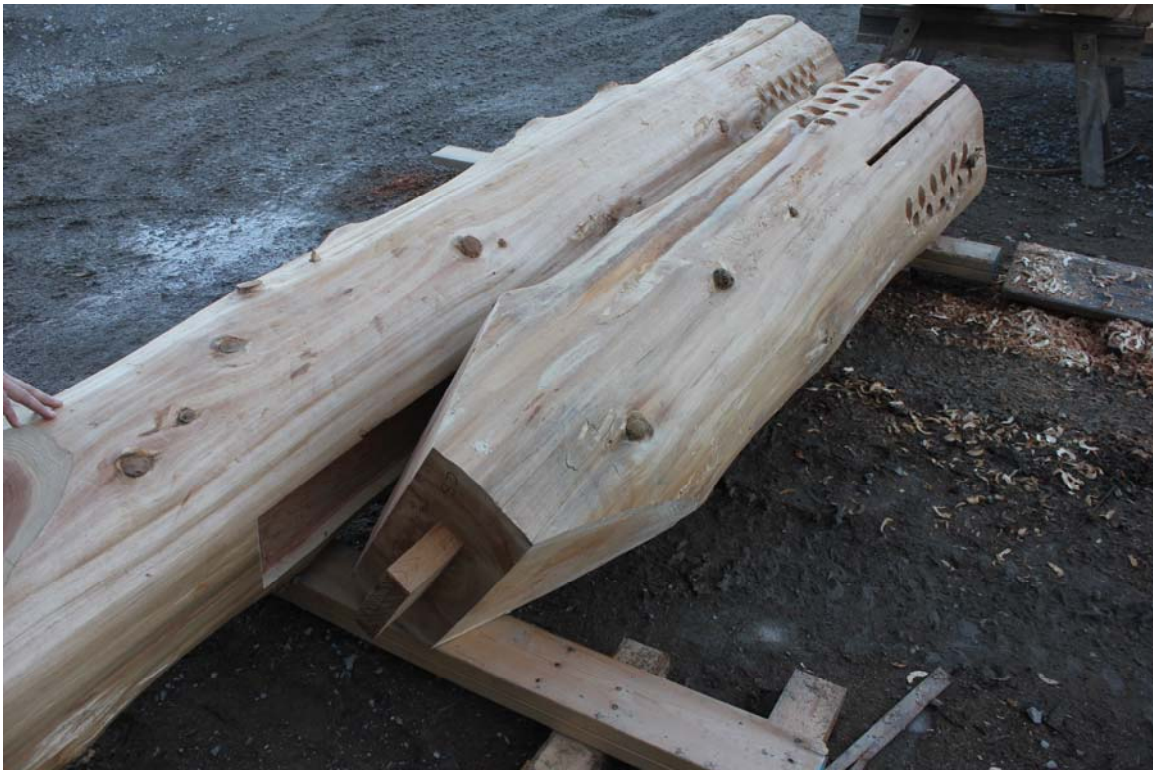
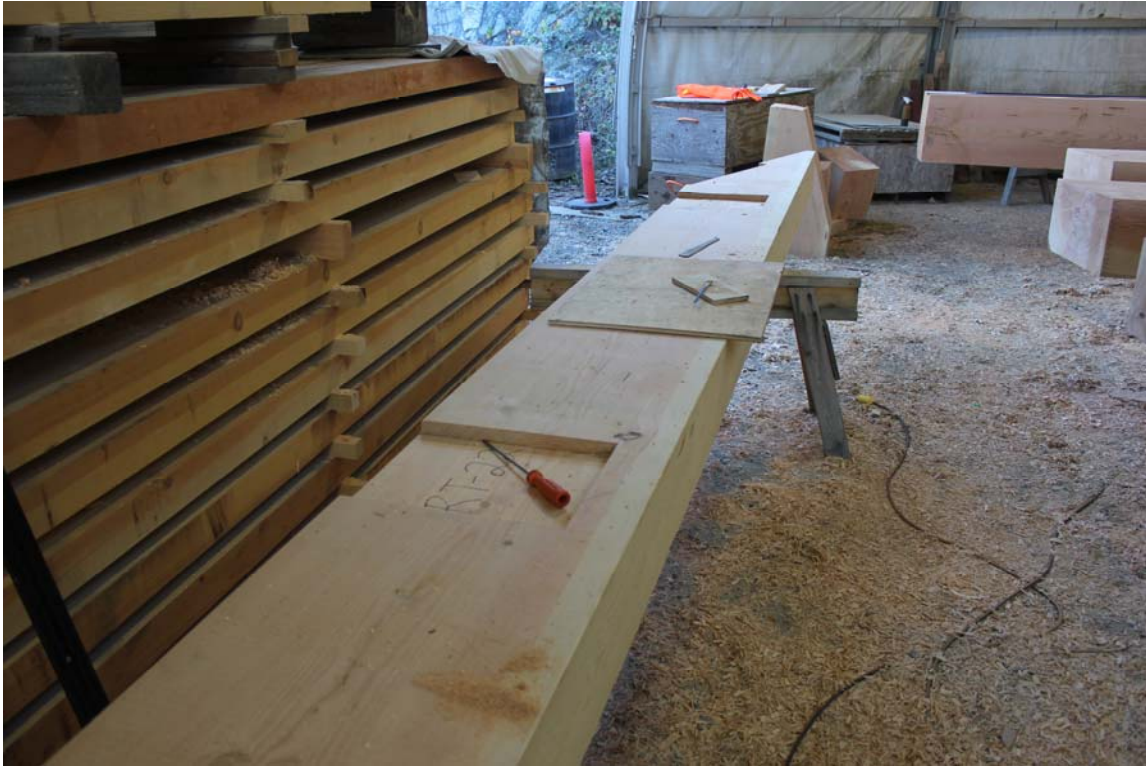
ITEM	PHOTO	COMPONENT	OBSERVATION	COMMENTS
A1.3	04, 05	Timber frame	Fabrication of timber frame in progress	Quality of work high
A1.4	06	Timber frame	Drilling of holes for bolts at base of wood columns	Edges of drilled holes to be chamfered smooth
January 29, 2019				
A2.1	07, 08	Multipurpose building	Wood framing and timber frame installation in progress	
A2.2	09, 10	Recreation Centre covered area	Installation of timber frame in progress	Quality of workmanship very high
A2.3	11, 12	Recreation Centre north wall	Sections of north wall built in 2x8 framing (instead of 2x6) to accommodate steel frame	Step in wall thickness to be concealed at wall junctions or by application of two layers of drywall.
A2.4	13	Wood trim around windows and doors	Membrane to lap over door and window frames to ensure airtightness	Wood trim around windows and doors to have dado edges to conceal membrane
A2.5	14	Moisture barrier at windows and doors	Moisture barrier to continue around all sides of window and door openings	Ensure continuity of moisture barrier at doors and windows. All joints to be taped.

Photo 04: Timber frame: Fabrication

Photo 05: Timber frame: Fabrication

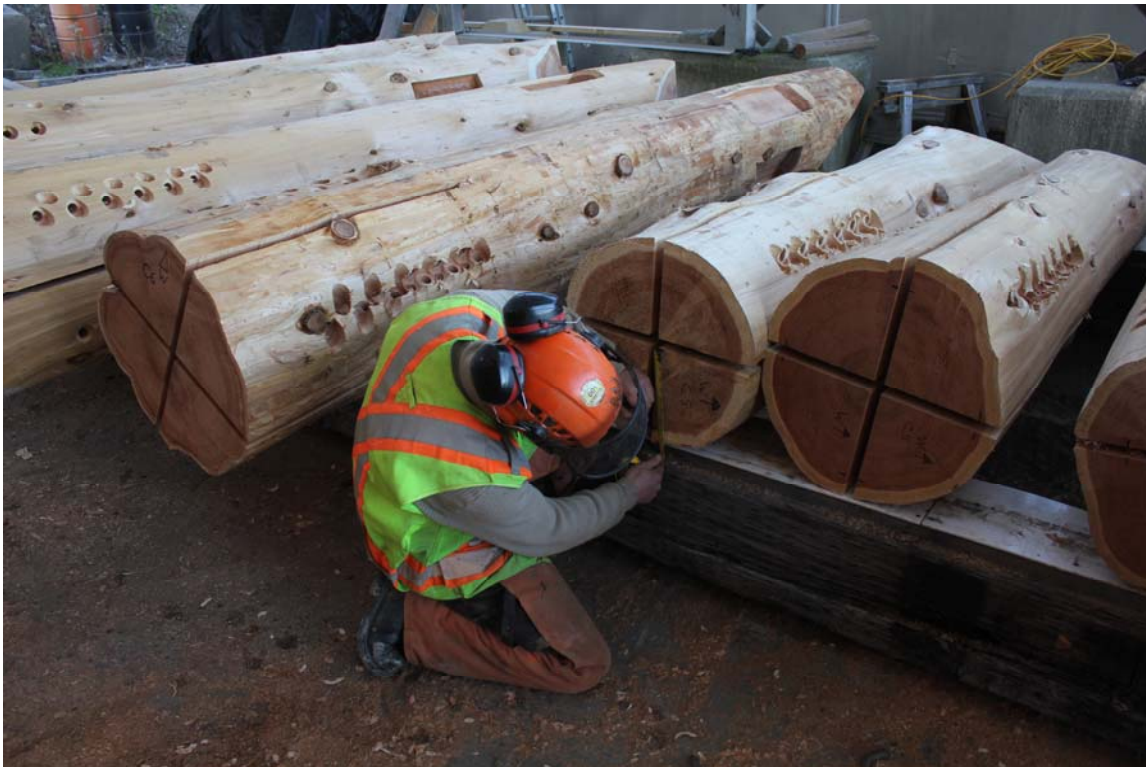
Photo 06: Timber frame: Fabrication: bolt holes

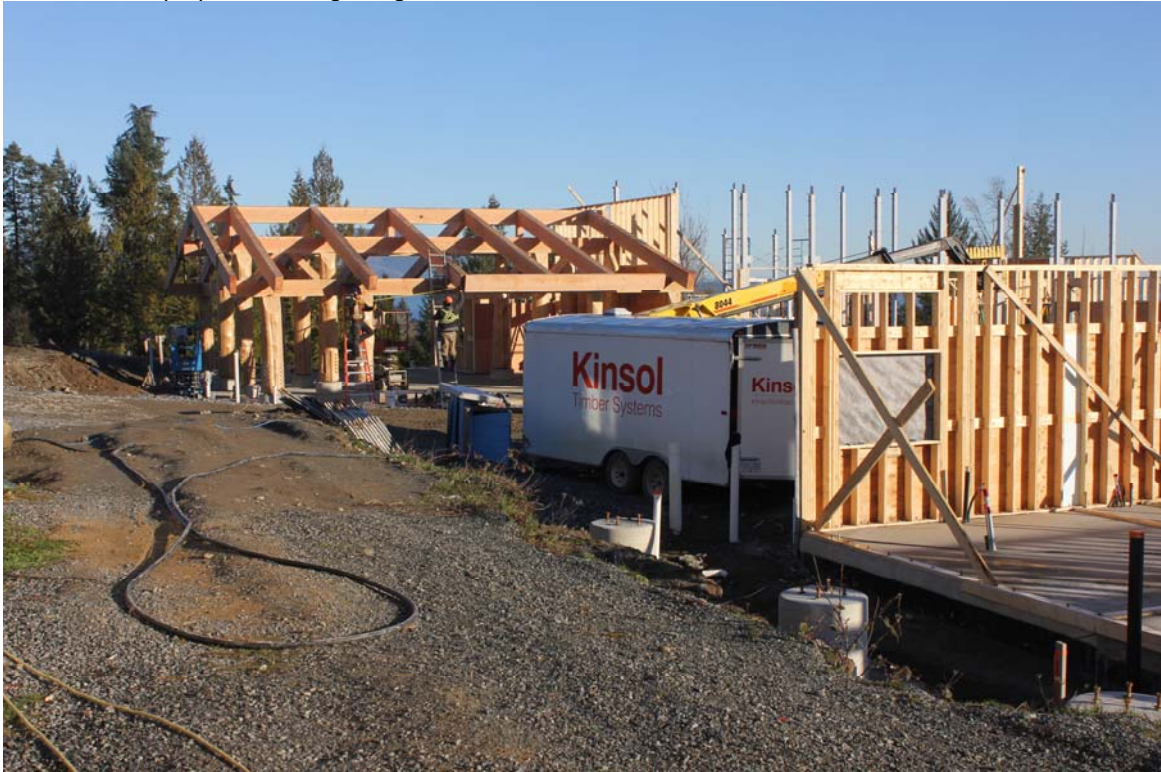
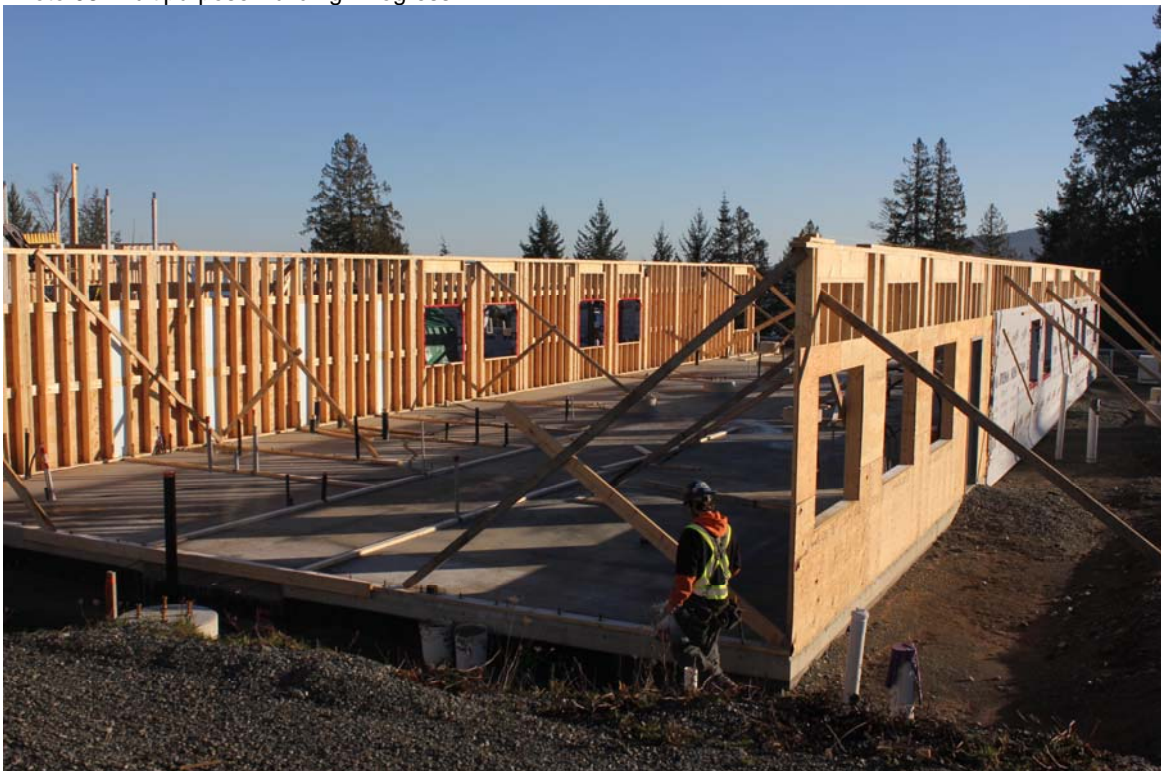
Photo 07: Multipurpose Building: Progress

Photo 08: Multipurpose Building: Progress

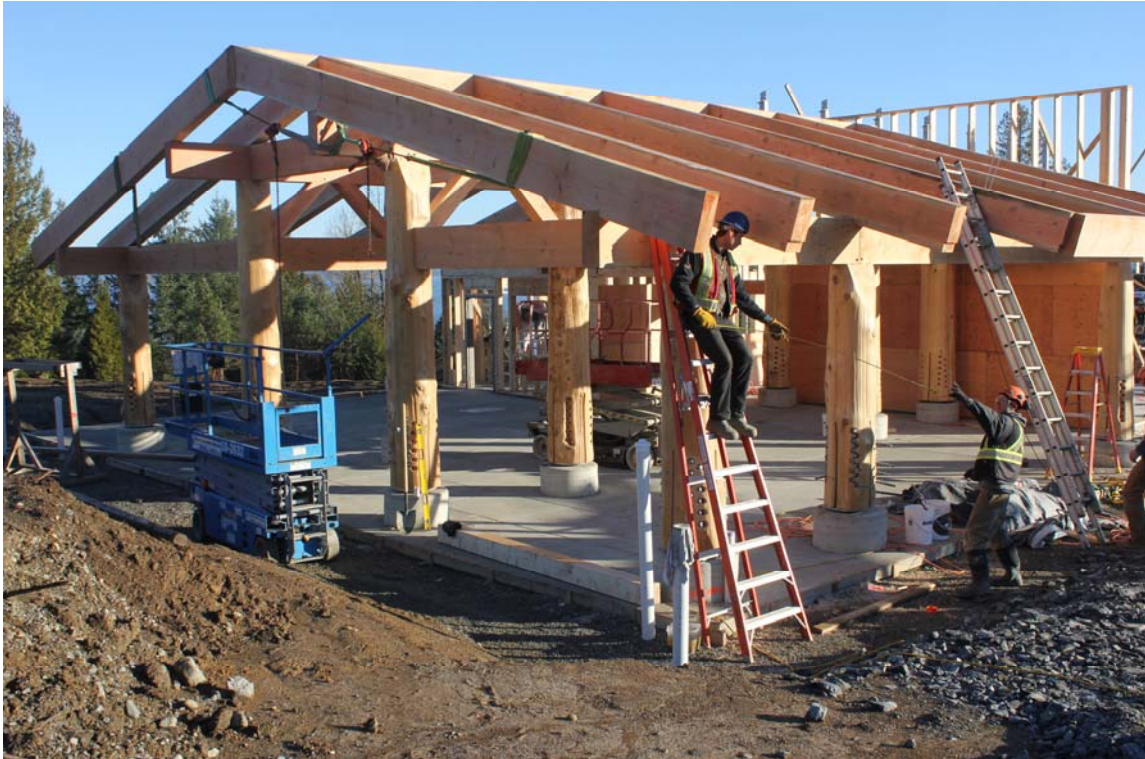
Photo 09: Recreation Centre: Covered area: Timber frame

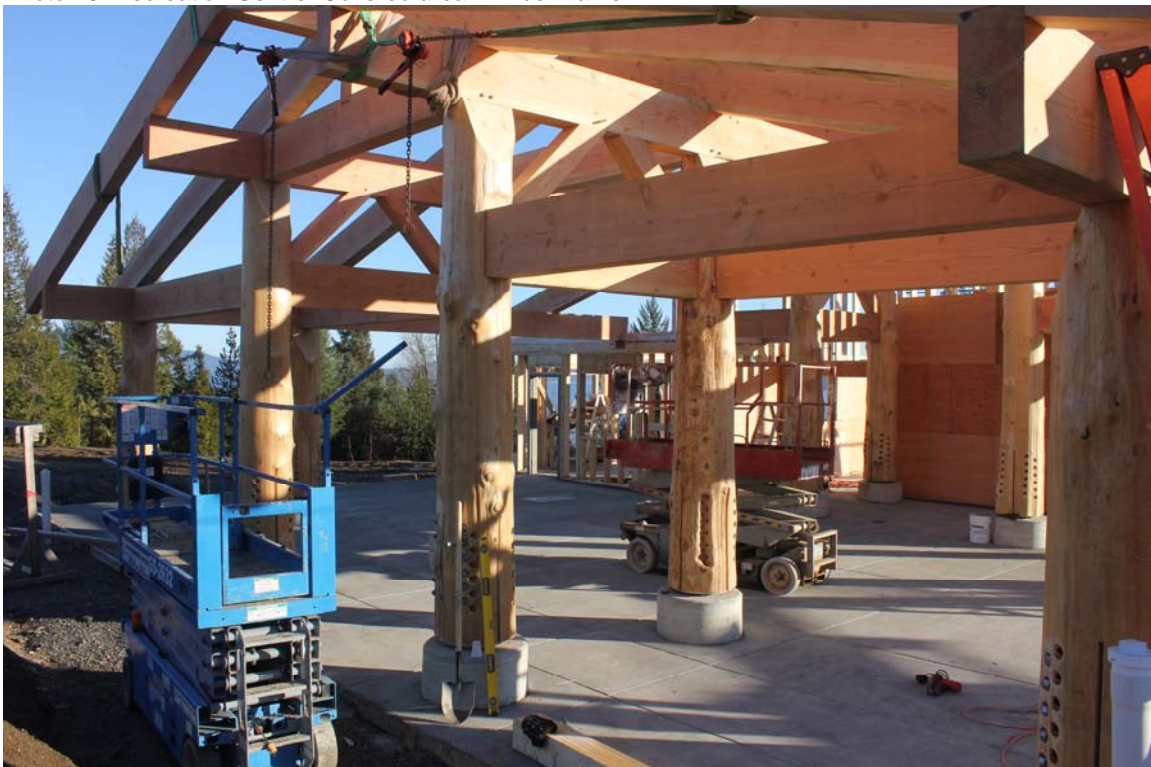
Photo 10: Recreation Centre: Covered area: Timber frame

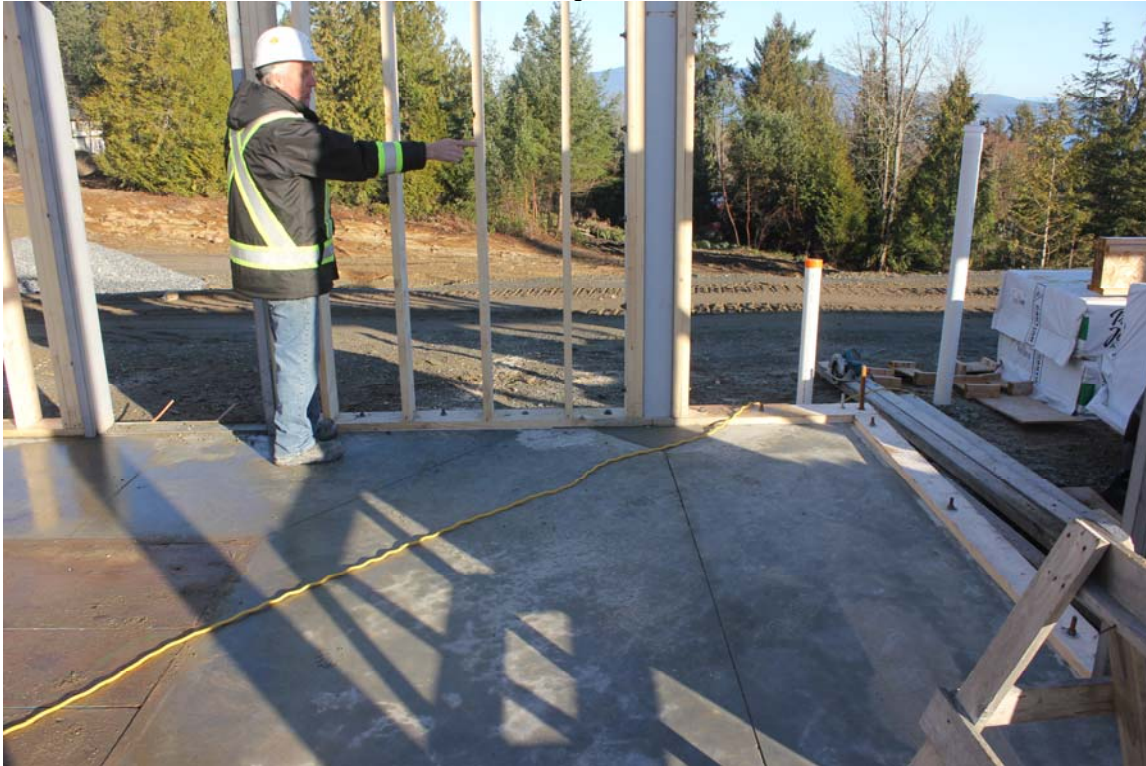
Photo 11: Recreation Centre: North wall: wood framing and steel columns

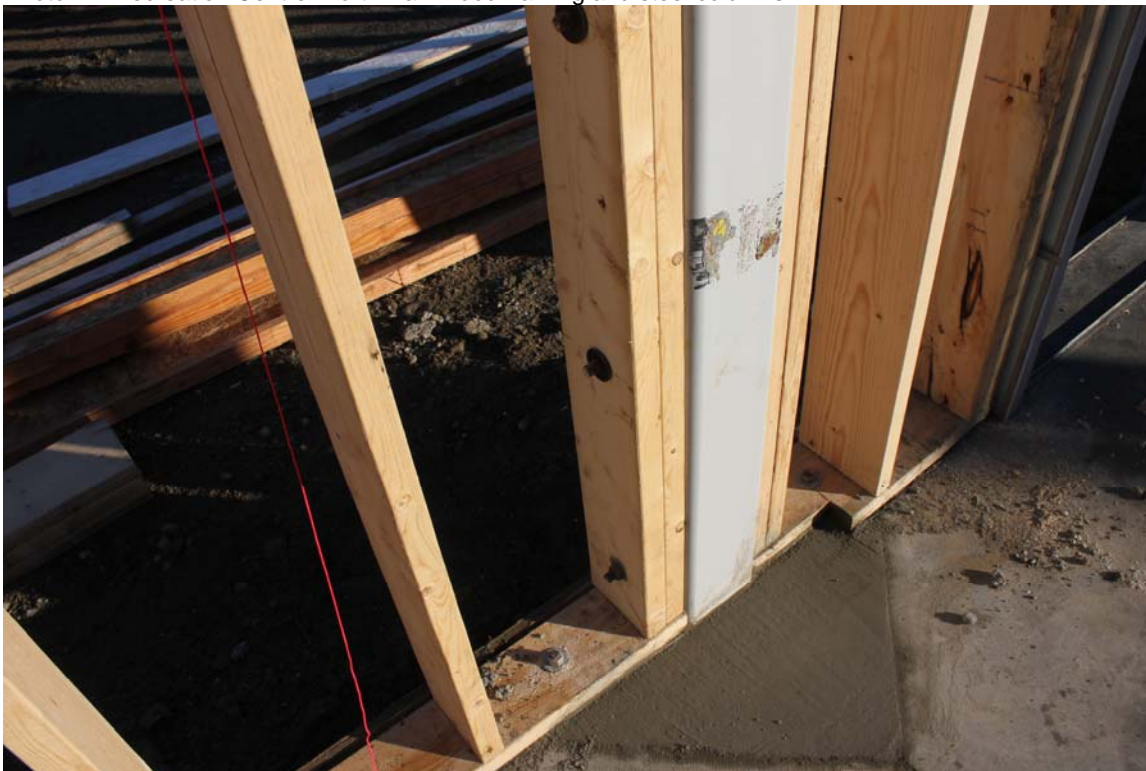
Photo 12: Recreation Centre: North wall: wood framing and steel columns

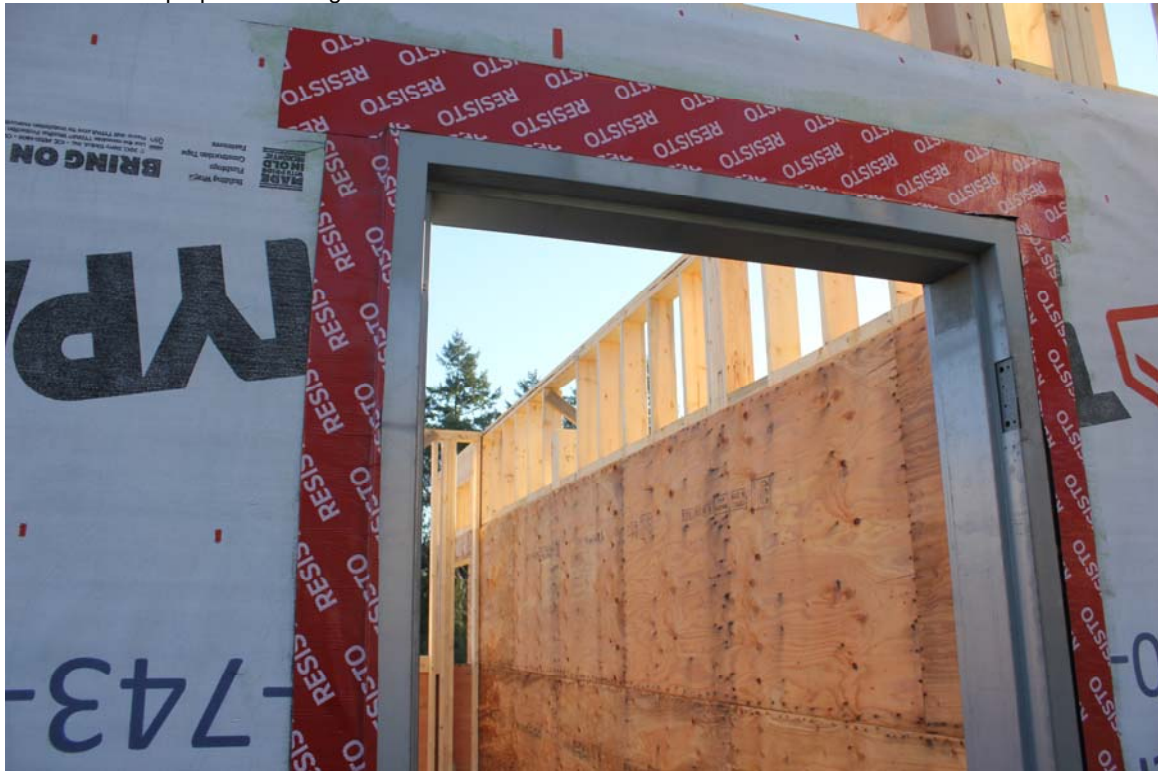
Photo 13: Multipurpose building: Membrane around doors and windows

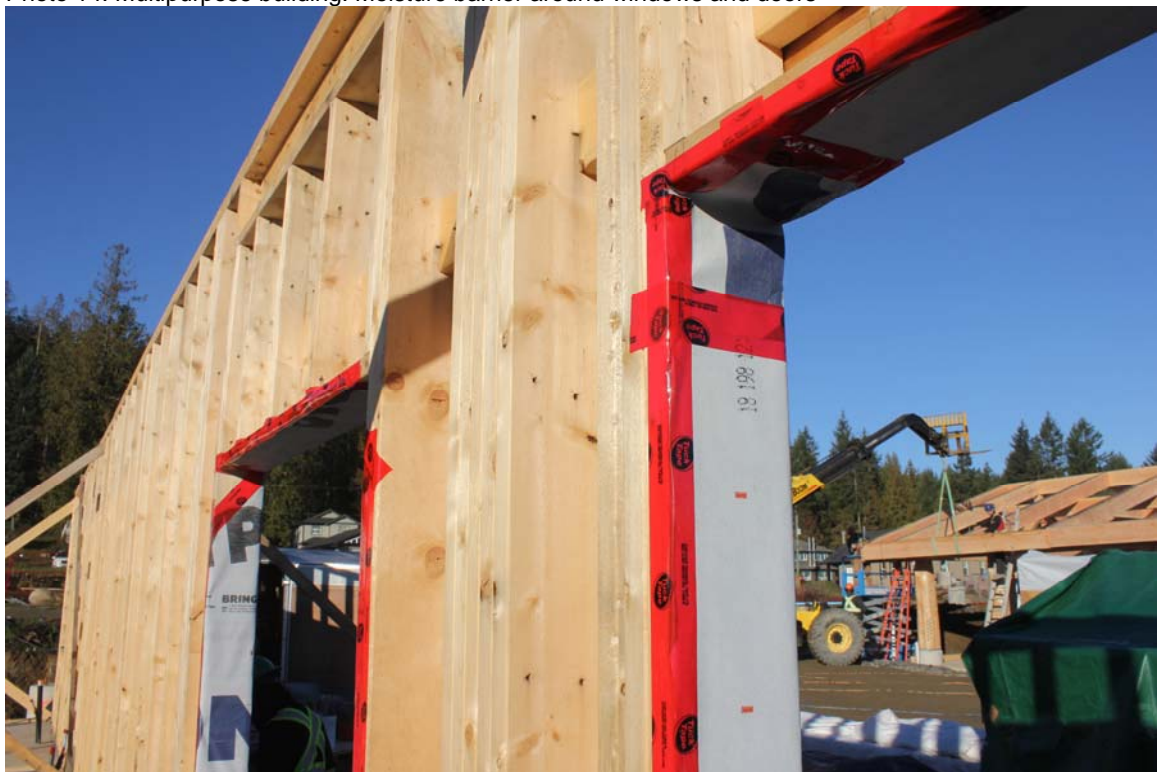
Photo 14: Multipurpose building: Moisture barrier around windows and doors

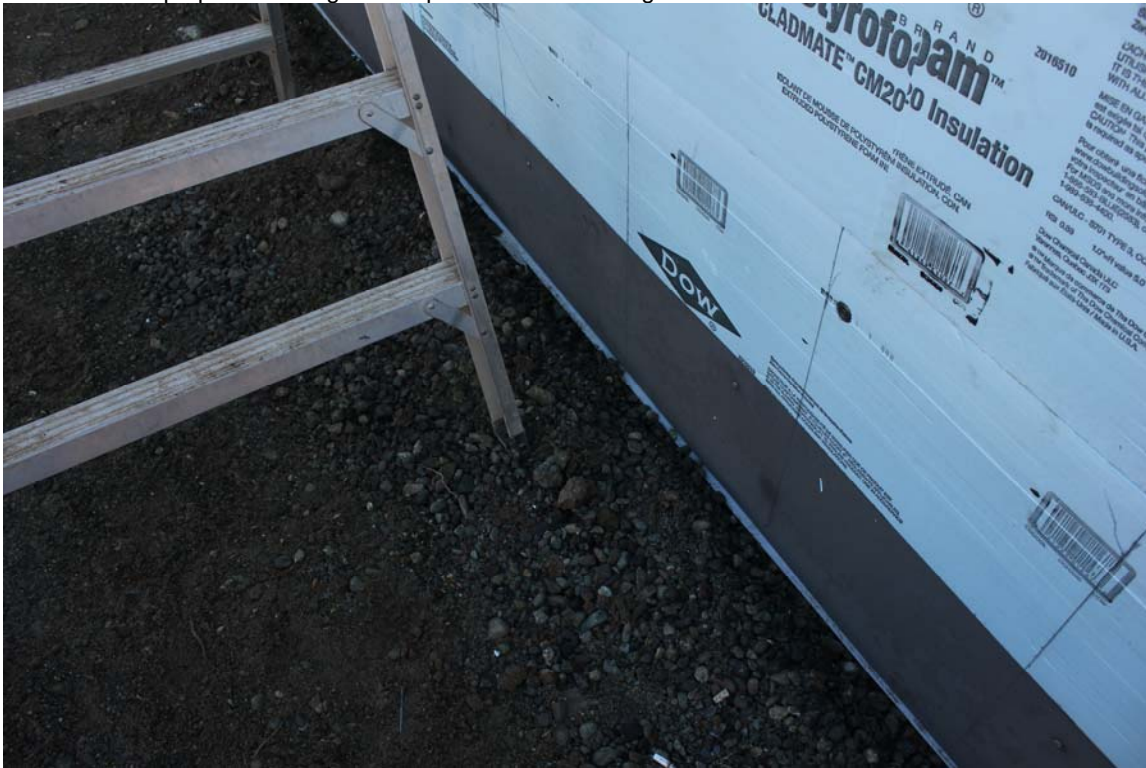
A2.6	15	Envelope	Installation of sheet metal covering exterior insulation at base of façade in progress	Membrane required at top of sheet metal to ensure continuity of moisture barrier. Ensure cavity space is vented top and bottom with flashing at bottom directing water to exterior
A2.7	16	Timber frame	In some locations, fasteners are required through face of wood	If surface fasteners are required, screws are to be countersunk and wood dowels installed
A2.8	17	Timber frame	Details required for 6x6 wood columns at entrance glazing,	Wood column at entrance glazing to be kiln dried. Architect to provide drawings showing installation details of wood columns and windows.

Photo 15: Multipurpose building: Envelope at base of building

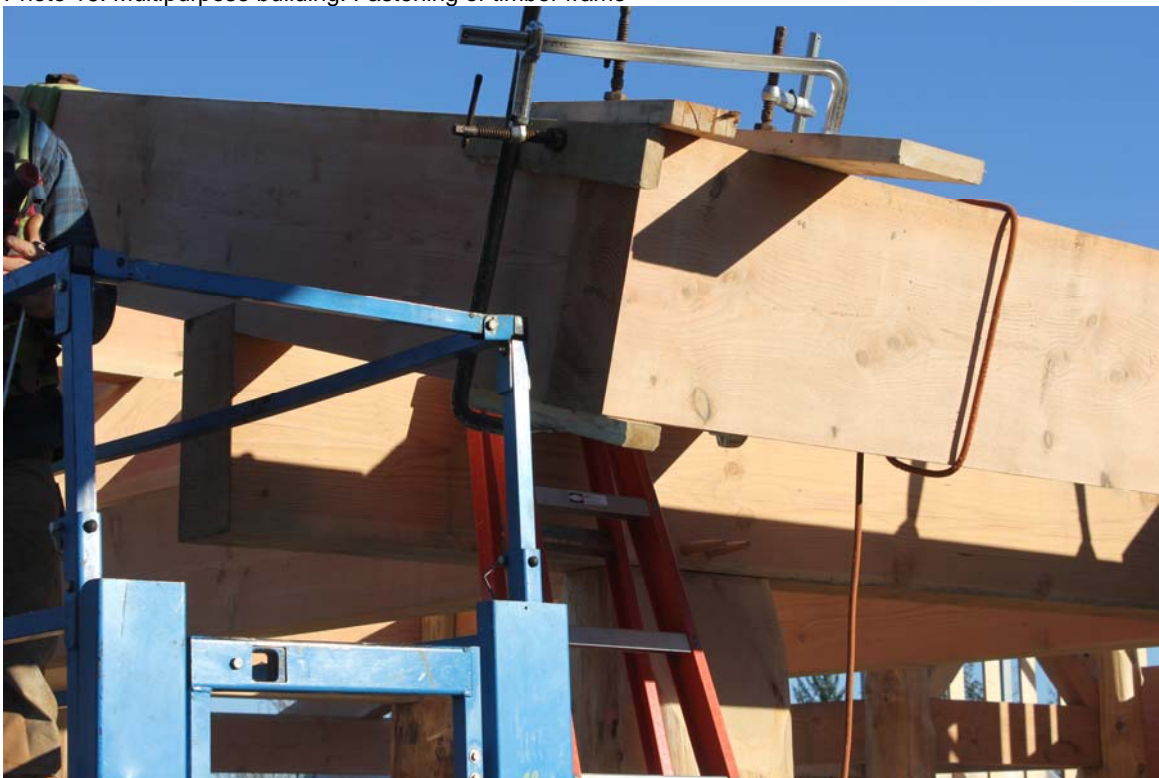
Photo 16: Multipurpose building: Fastening of timber frame

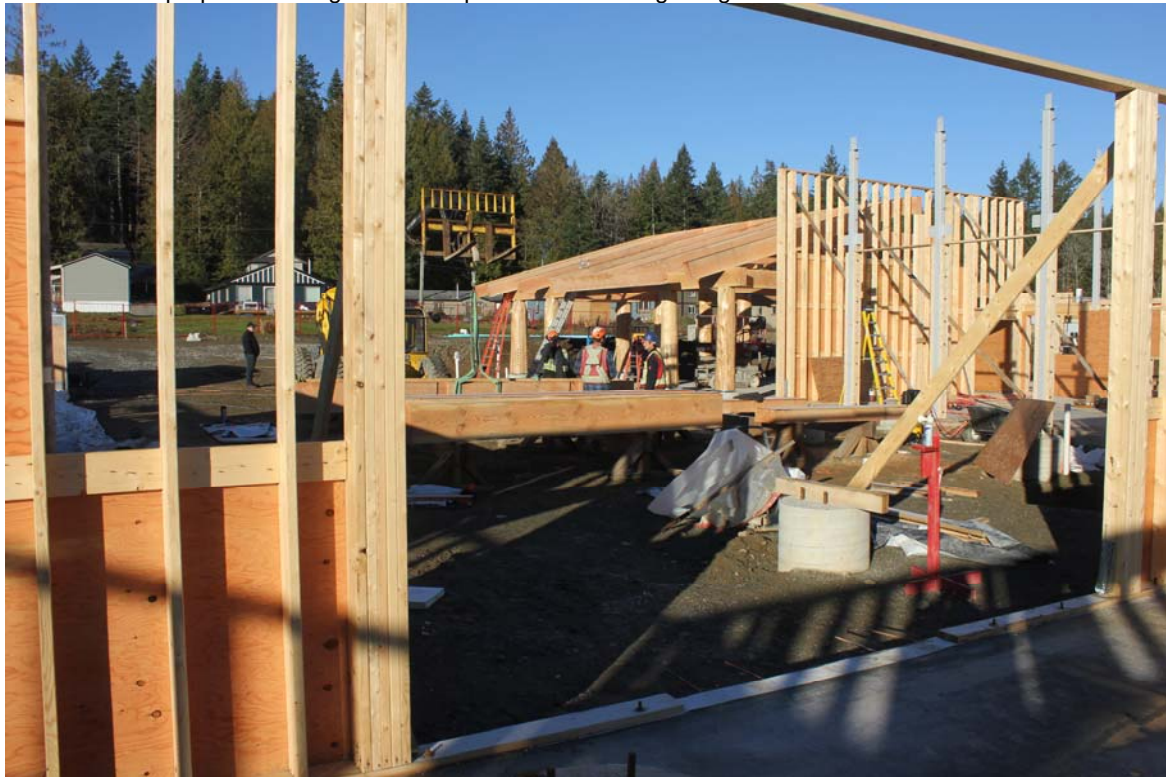
Photo 17: Multipurpose building: 6x6 wood posts at entrance glazing
